SPRING BROOK INTAKE DAM

NDI ID NO. PA-00450
DER ID NO. 35-40

PHASE I INSPECTION REPORT
NATIONAL DAM INSPECTION PROGRAM

APRIL 1980

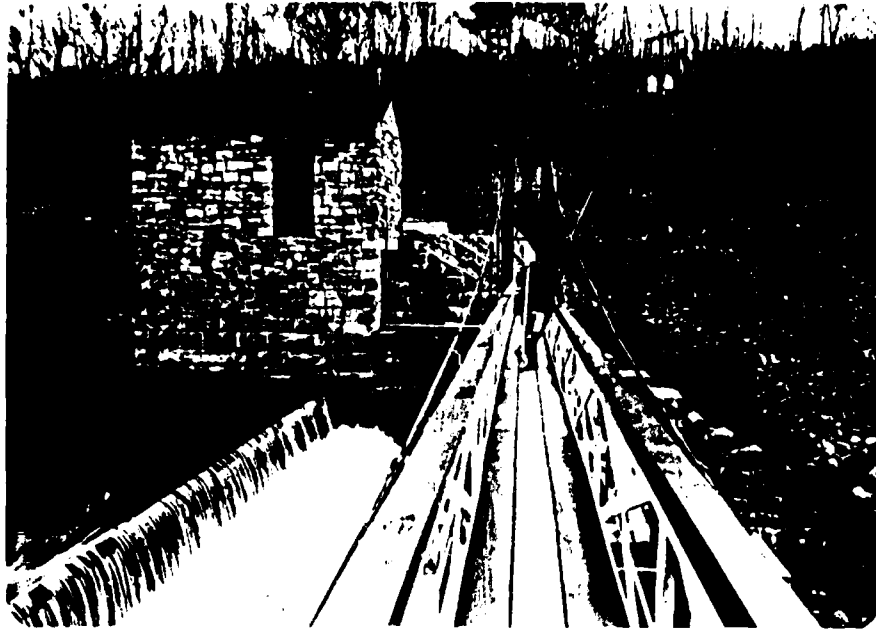
C. Left Outlet Works and Main Spillway

c. Appurtenant Structures. The main spillway and main spillway apron are in good condition (Photographs C,

E, and F). Some minor deterioration of some mortar was evident. The auxiliary spillway and auxiliary spillway apron are also in good condition, with the mortar in approximately the same condition as the main spillway (Photographs G and H). Probing with a rod indicated that a hole about 8 feet deep exists at one location immediately downstream of the downstream end of the auxiliary spillway apron. Fairly large brush stumps were observed at the right abutment of the dam.
